Pisinemo Intertie

PWSID No. 04000030

Sanitary Survey
March 24, 2016

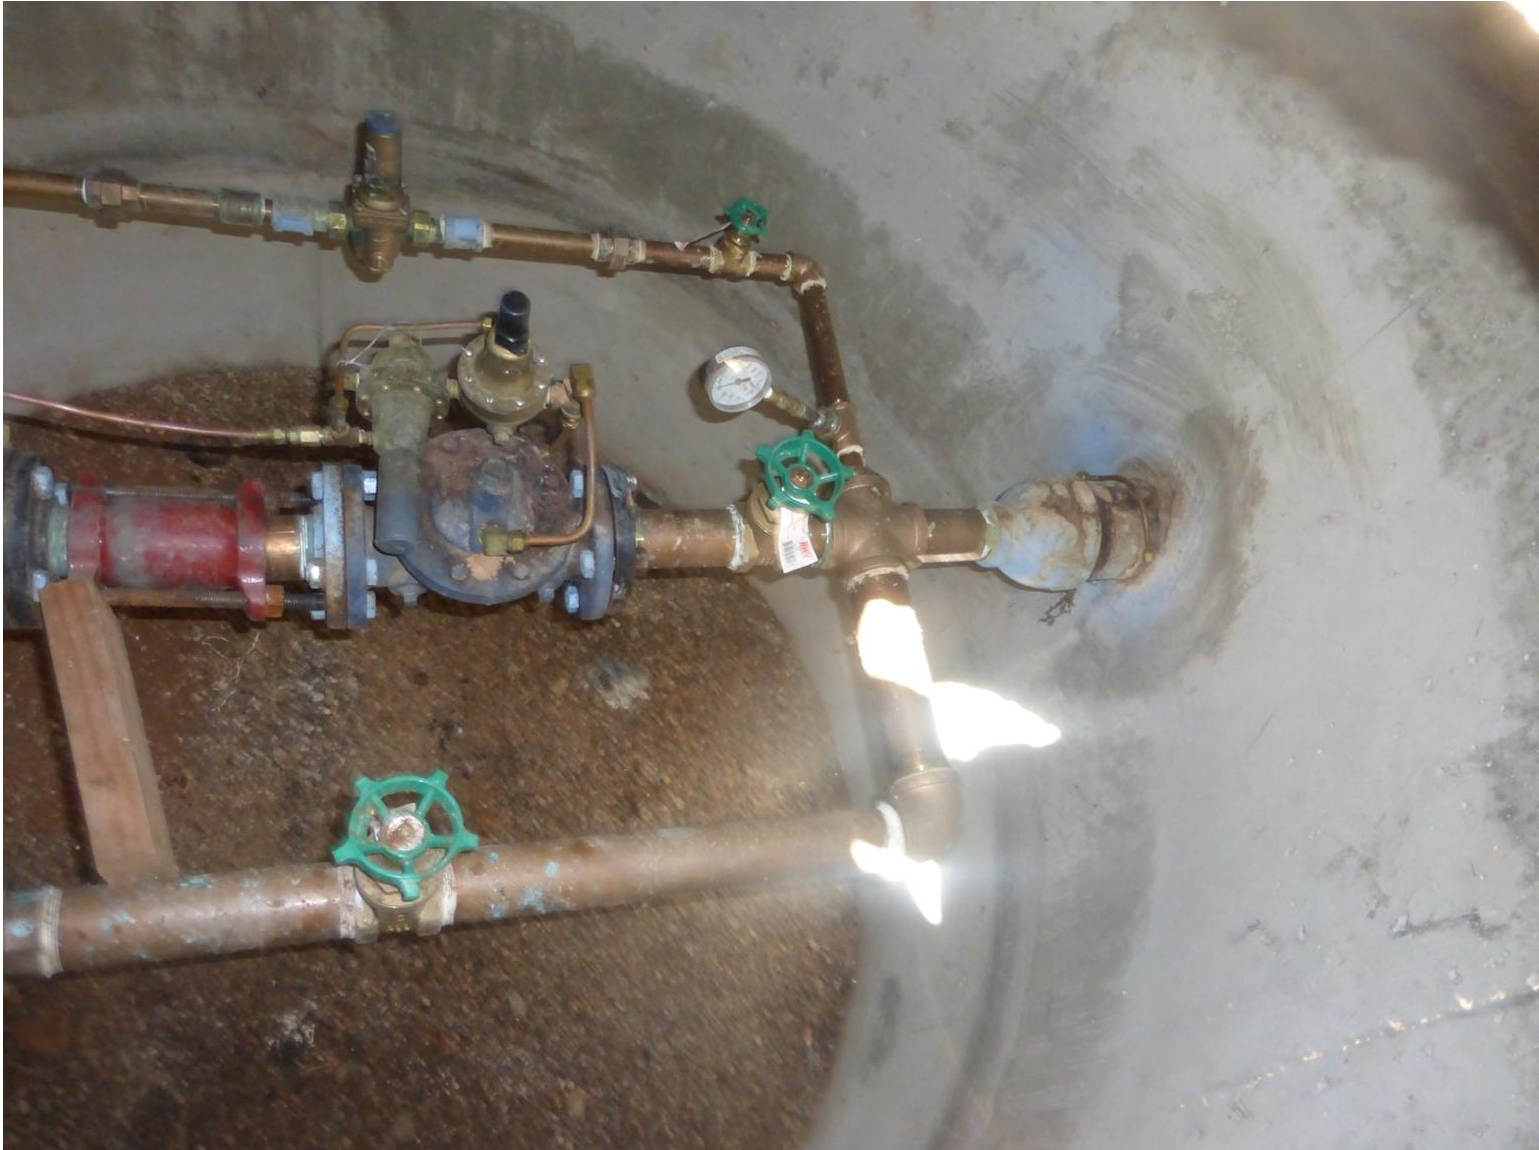
**100 psi pressure at home in Santa Cruz (DS002)—
Problem with PRV between Pisinemo and Santa Cruz.**

A pressure reading taken in Santa Cruz showed a reading of over 100 pounds per square inch (psi), indicating the PRV was not working.

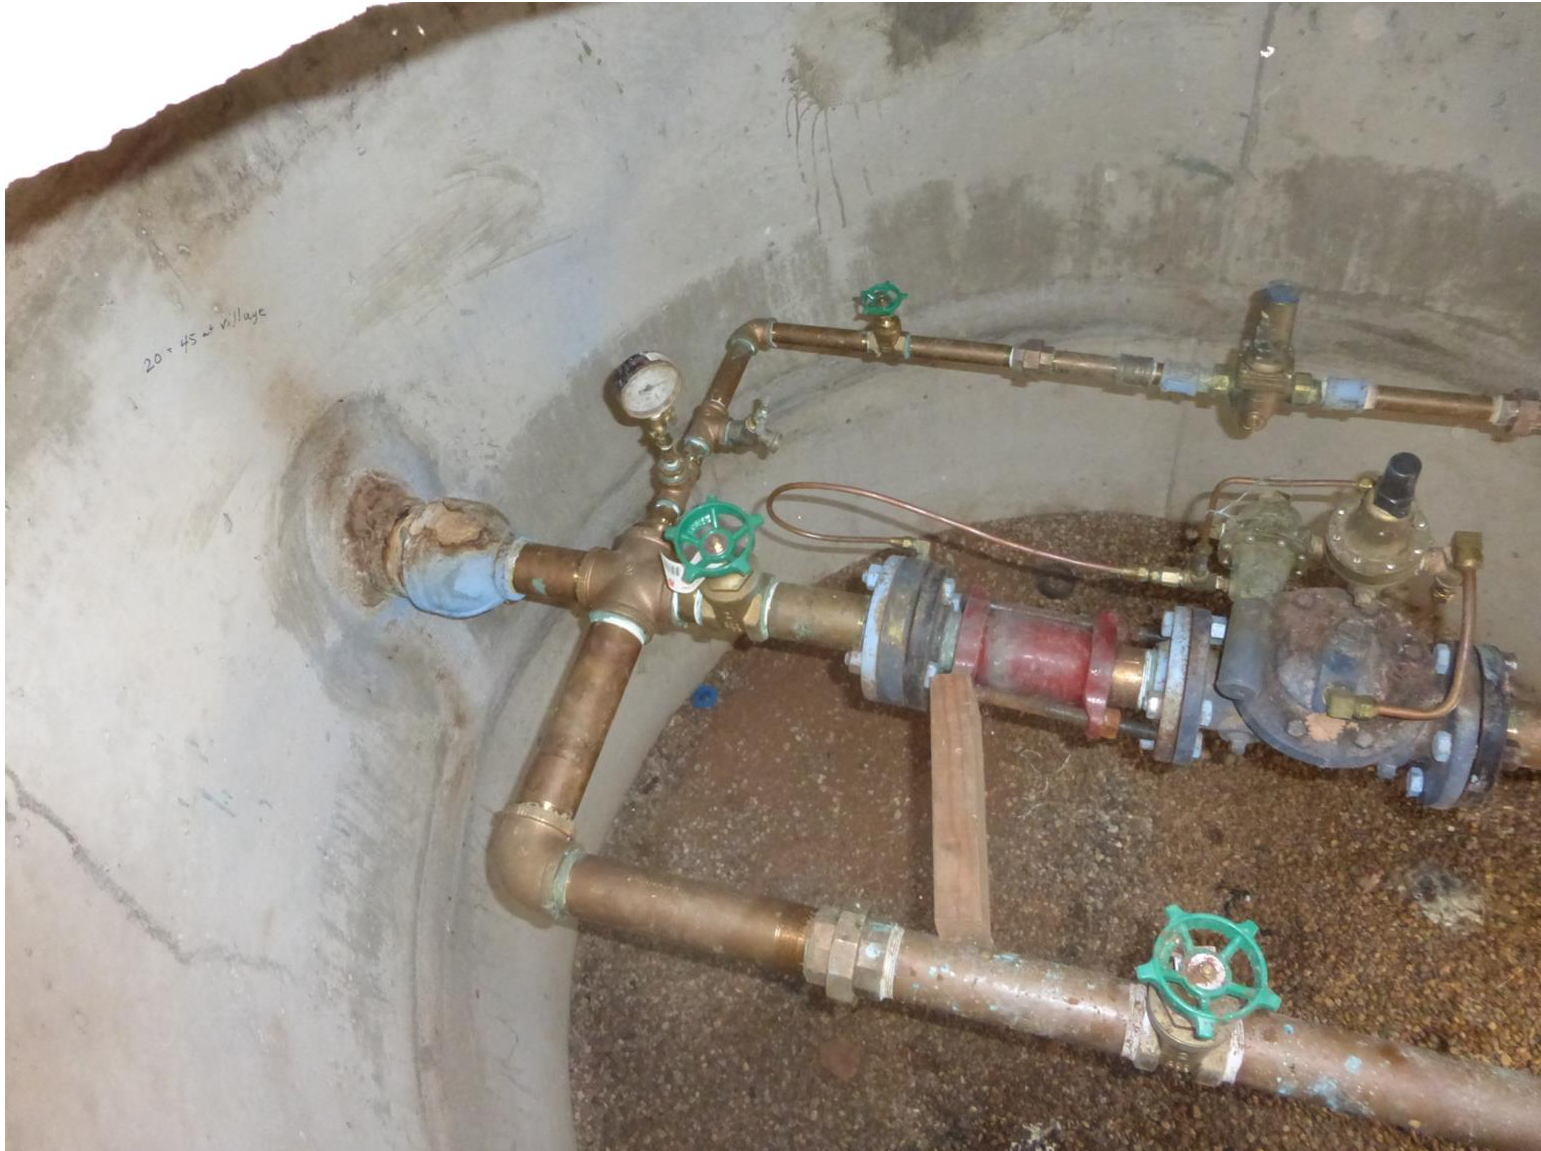
~85 psi pressure on downstream gauge on PRV station.
